# Manhole Inspection Summary

Manhole # S69E1\_003MH

**Location** Address: **6501 Colgate Ave.**

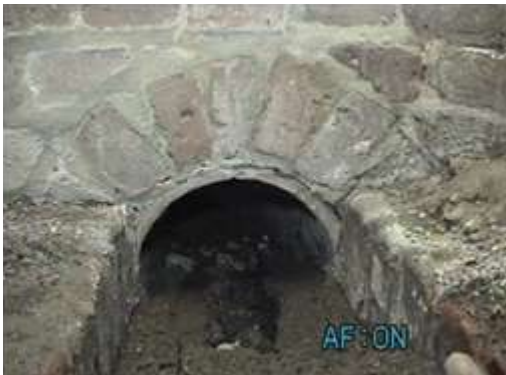
Defect 2

Condition: ☐ Sound ☐ Cracked ☐ Root Intrusion ☐ Deteriorated ☐ Leaks ☒ **Debris**

channel full of debris {surcharged}  
--debris also on bench

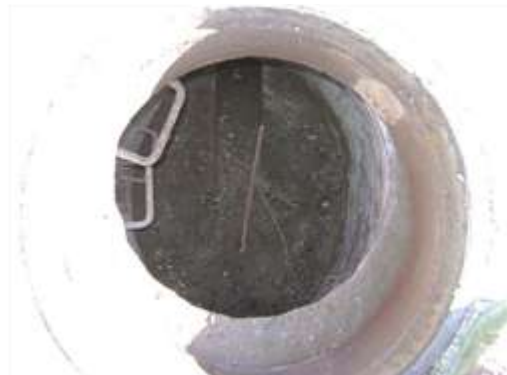
Defect 1

**Frame** Offset: **2** (in.) Condition: ☒ Sound ☐ Cracked ☐ Leaks

2 in. frame offset

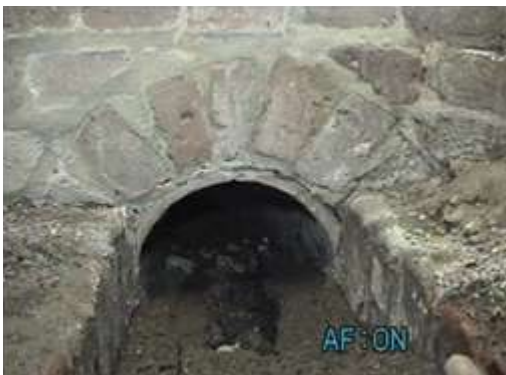
Defect 3

Cracked pipe seal outgoing 12 O'Clock

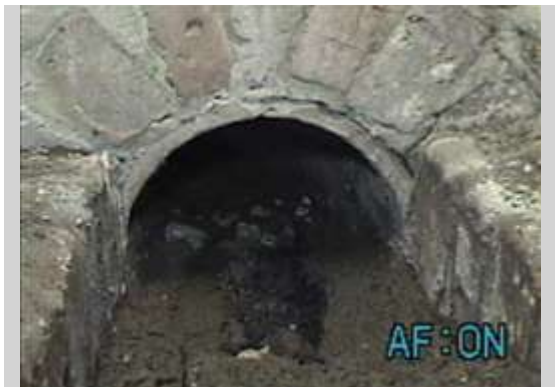
12 O'Clock Outflow

8 in. Circular Gravity Sewer  
Pipe Out @ 12 O'Clock

Pipe Height: **8.4** (in.) Rod and Bar (Angled)  
Pipe Material: **Clay** ☐ Pipe Lined  
Invert Depth: **5.92** (ft.) Flow Characteristics: **None**  
Deposits: ☐ None ☐ Mud ☒ ~~Gravy~~ **Debris** ☐ Grease  
Silt Depth: **2** (in.) Deposits Extent: **Heavy**  
Infiltration: **None** Pipe Seal Cond: **Sound**
